FACILITY STATUS CHANGE FORM

Date Submitted: February 21, 2013 Originator: Chris Strand Phone: 554-2720	Area: 300 Area Facility ID: 308A Action Memorandum: Action Memorandum #3	Control #: D4-300-081
----------------------------------------------------------------------------------------------------------------	--------------------------------------------------------------------------------------------------------------	---------------------------------

Attachment 1: Facility Information

Attachment 2: Project Photographs

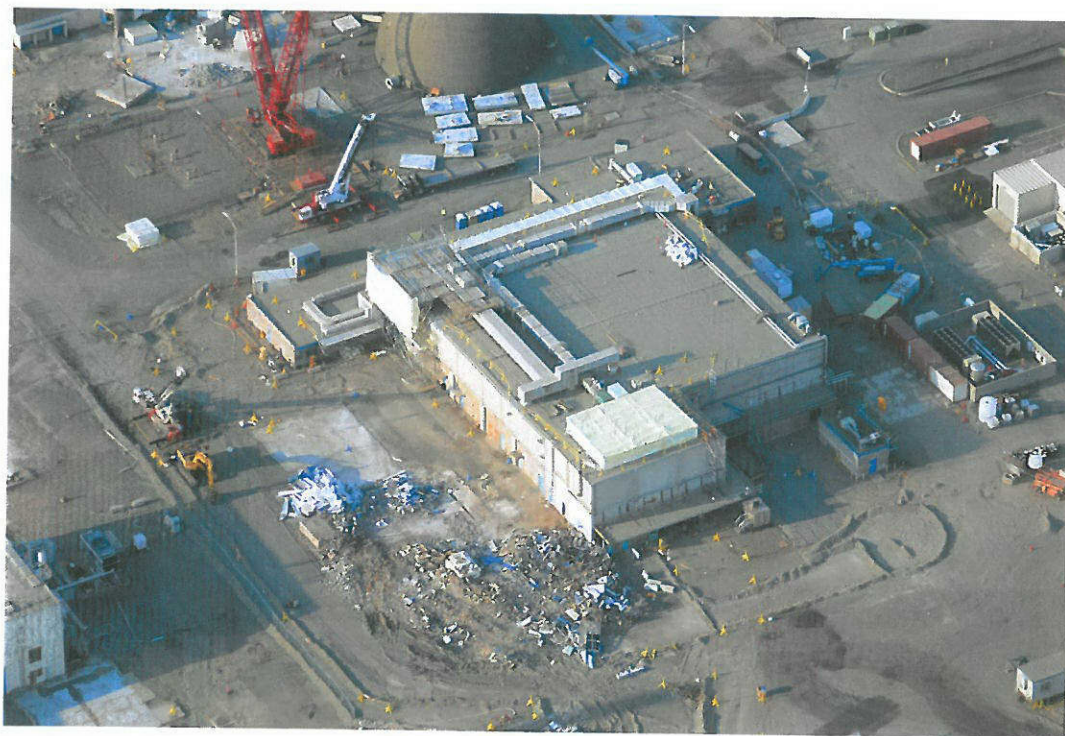
Photograph 3. Areal view looking southwest following above-grade demolition of 308A on September 8, 2011.

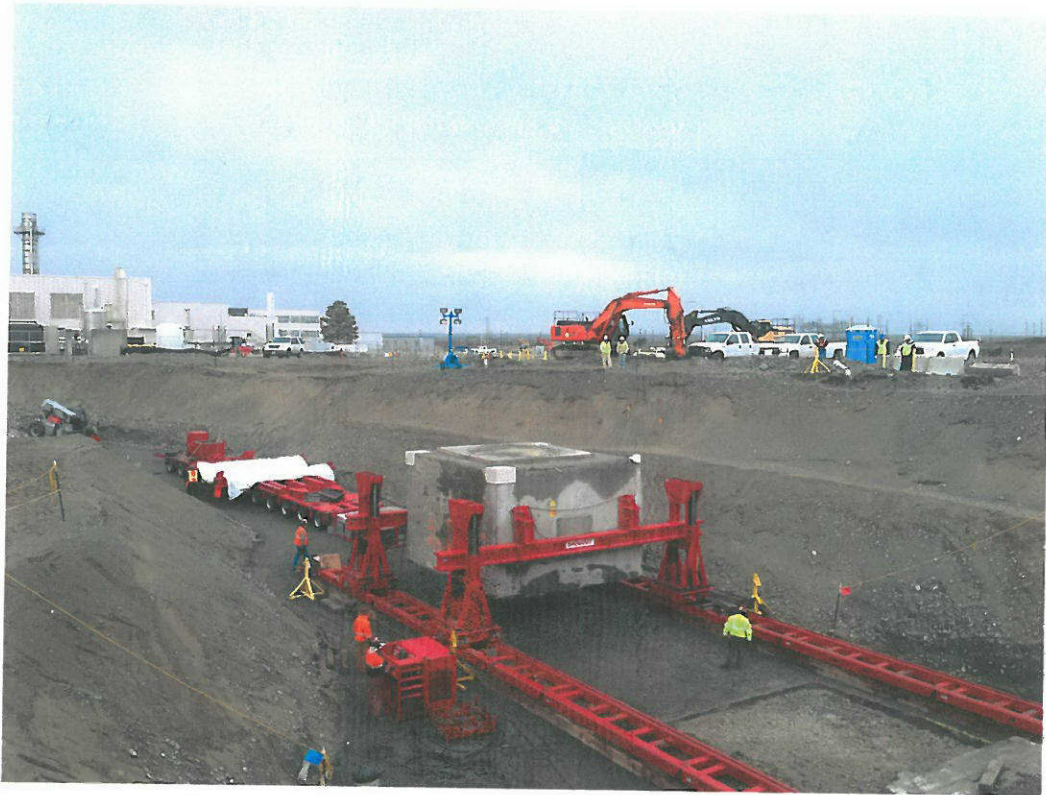
Photograph 5. Looking west as the TRIGA reactor is moved to the transportation trailer on December 15, 2012.

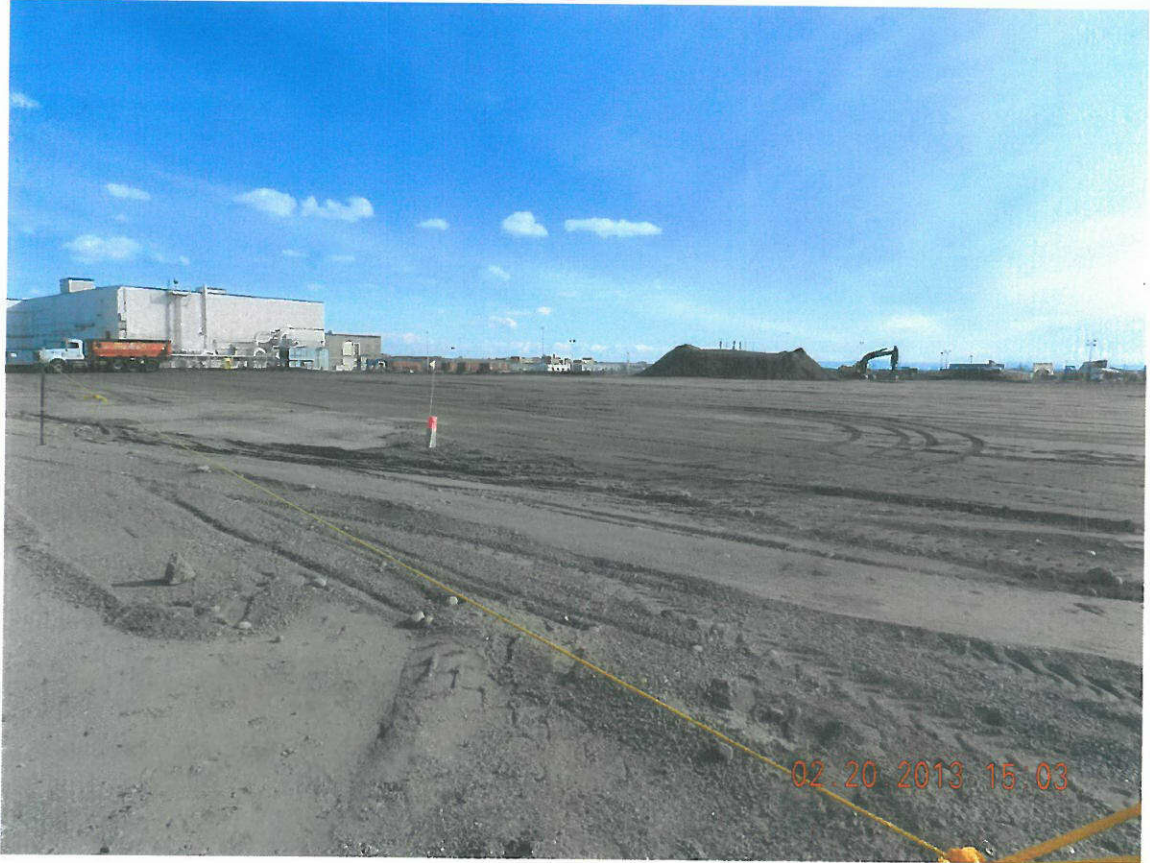
**Photograph 7. Looking southeast at the 308 and 308A site following backfill,
February 20, 2011.**
